Inspection Report

Minerals Regulatory Program

Mine Name: Bingham Canyon Mine	Permit Number: M/035/0002
Operator Name: Rio Tinto - Kennecott Utah Copper	Inspection Date: March 10, 2011
Inspector(s): L Heppler, P. Brinton	Time: 8:00 AM
Other Participants: Zeb Kenyon and others	Mine Status: Active

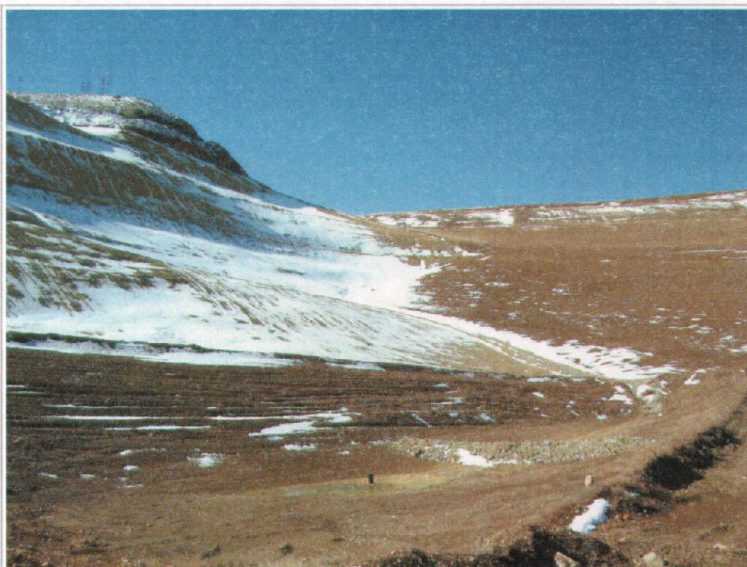
Maintained sediment basin

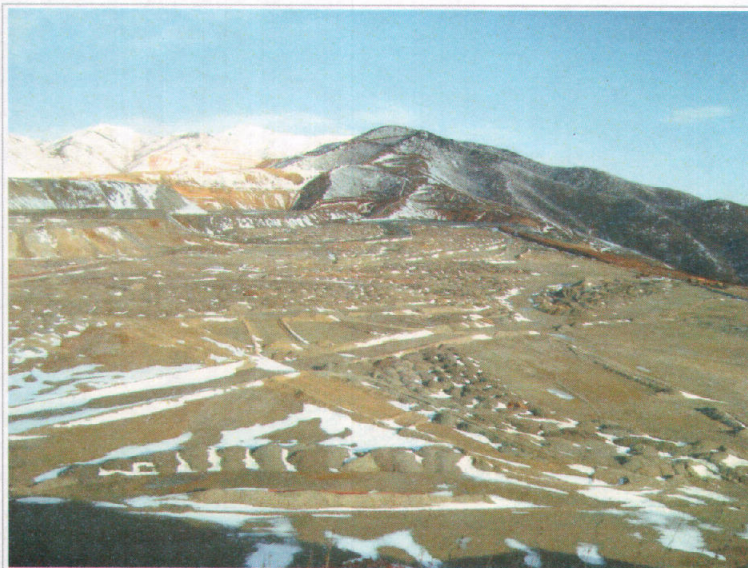
Top of dump in Bingham Creek – note topsoil salvage area in background

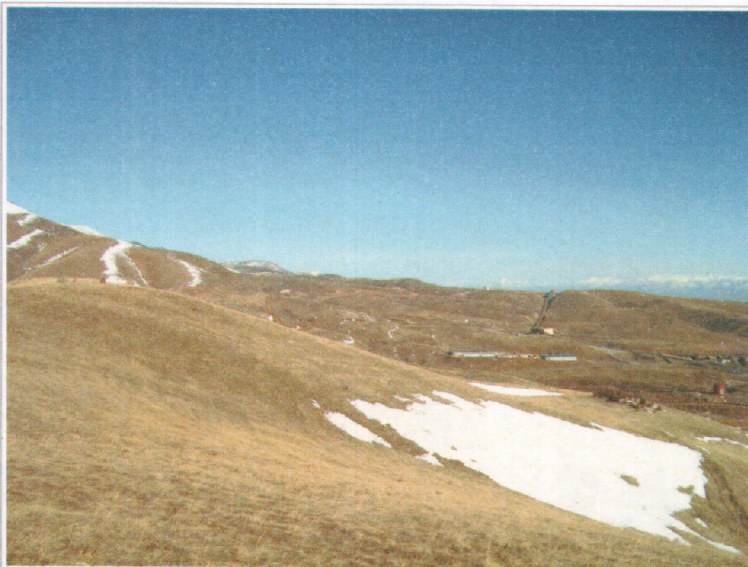
Older reclaimed dump

Conclusions and Recommendations: OGM recommends working on biodiversity of vegetation in areas that have been reclaimed. OGM to continue annual inspections and monitor the site when in the area

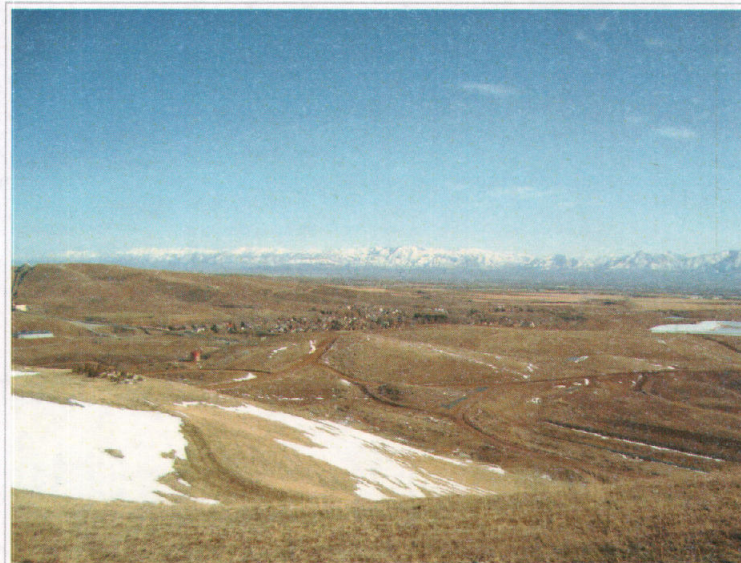
Older reclaimed dump
